Can Common PD Emissions be Detected at Multiple Frequencies?

By Greg Linton, HV Diagnostic Services Limited

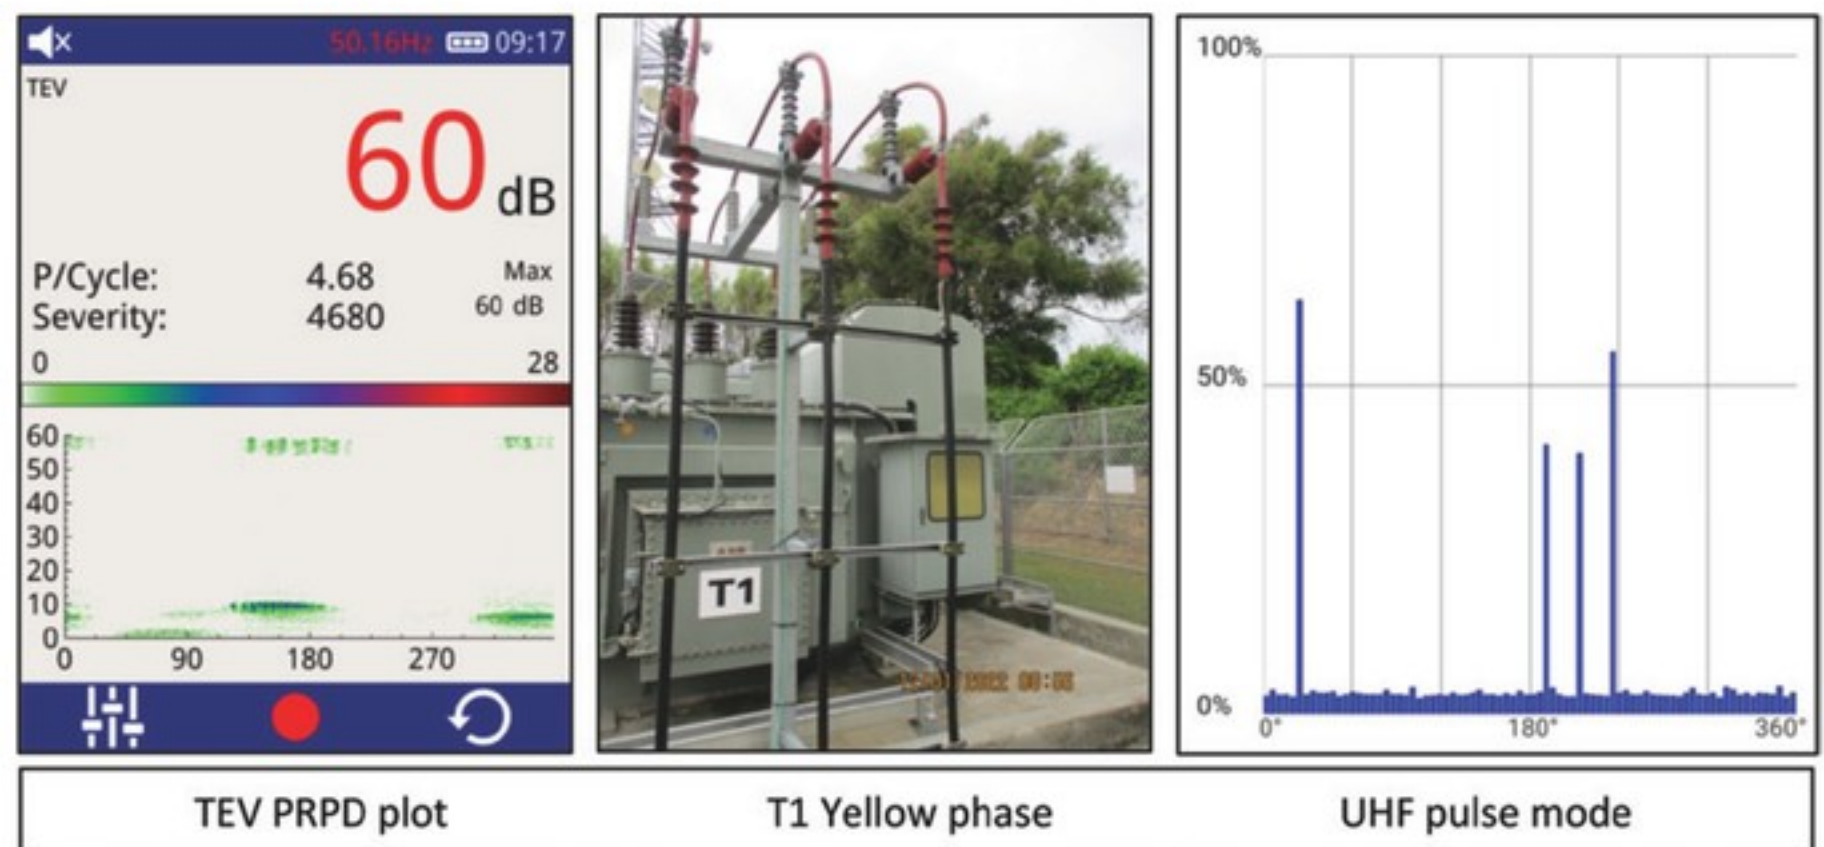
Case Study 1

Firstly, elevated TEV signals were present on various indoor 11kV switchboard panels and Incomer cables (max 31dBmV) while outside the UHF sweep led us to Transformer T1, whereby a subsequent TEV measurement on the Yellow phase 33kV cable confirmed 60dBmV at a pulse rate of 4.68ppc. The Phase resolved Partial Discharge plot (PRPD) is not typical of an

internal void type pattern however does exhibit the phase resolved signal indicative of discharge. Turning our attention to the UHF pulse mode scan we see two groupings spaced 180 degrees apart and note the 4 pulses per cycle (one screen width) consistent with the TEV screen (UHF scan completed at 807MHz at gain of 27). Note Ultrasonic was also present from the top clamps on the insulated risers and the floating non-referenced nature of this arrangement is likely responsible.

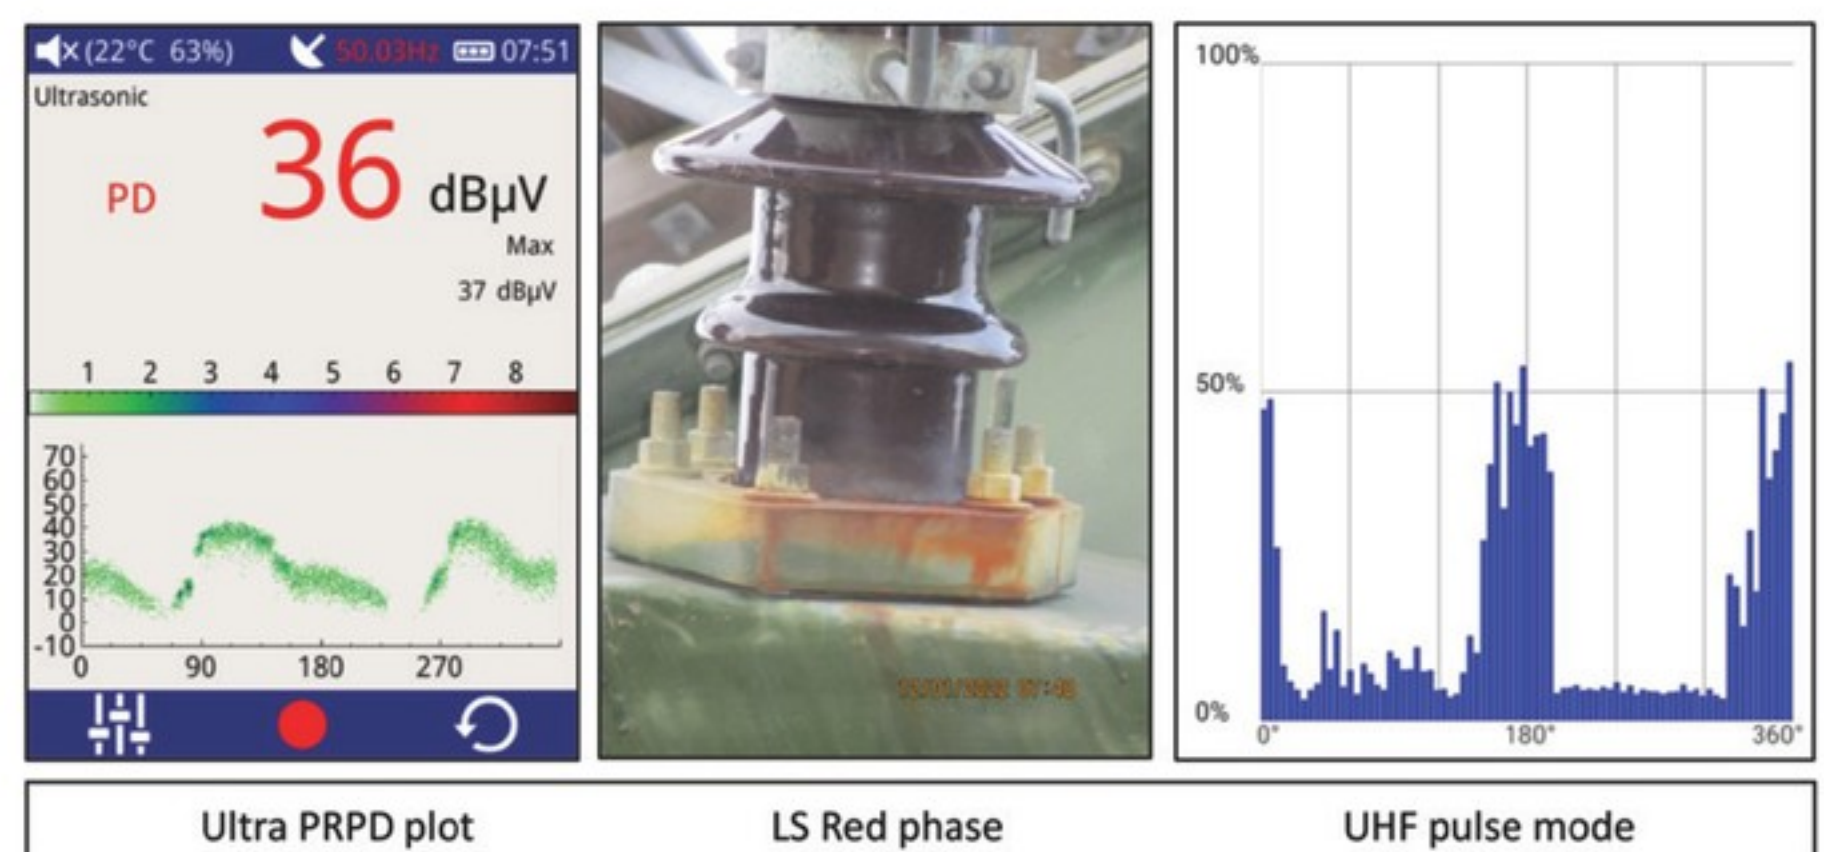
Case Study 2

Secondly, at a different location on the same Network high Ultrasonic was present from the base of the Red phase Bushing on a tired looking Local Service Transformer and you can make out the white residue at the discharge site 'clouding' the porcelain surface. The PRPD is near textbook in shape, again displaying 180 degree separation inferring discharge in each half cycle while surface PD 'discharges' at a much higher rate per cycle (can be upwards of 30ppc)

and although not directly measured is graphically represented in the UHF result. This defect may not be at risk of imminent failure but continued Oil leaks together with the dirty surface / contaminants could conspire to flash over under ideal conditions for what ought to be a relatively easy clean-up.

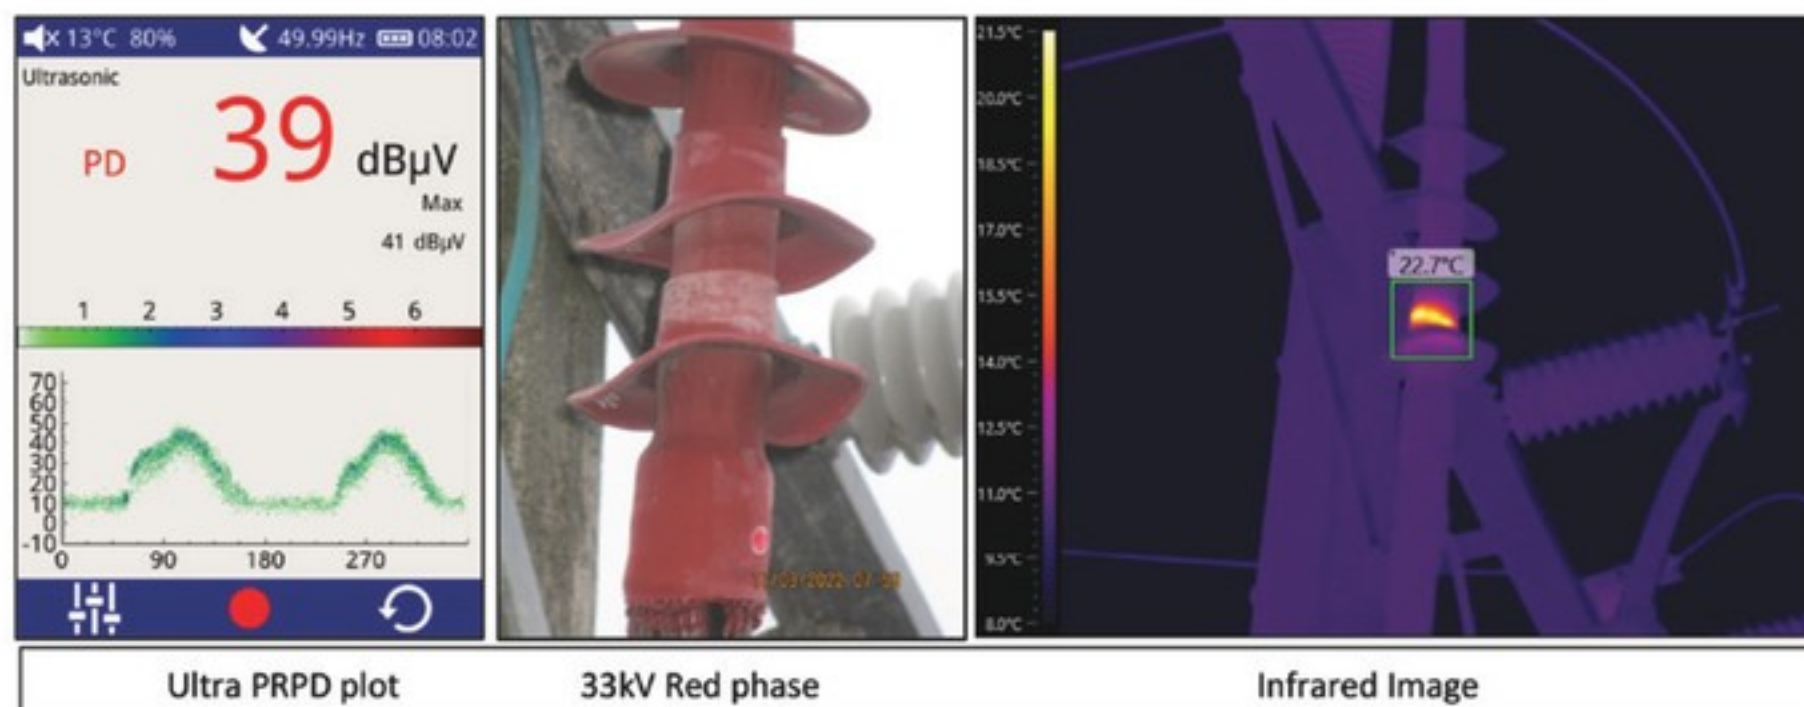
Case Study 3

This final study, from a more recent survey shows Ultrasonic Surface discharge also manifested as an Infrared emission with activity indicating a high stress area on the top of the lower rain shed. Infrared Imagers 'see' heat radiated from your equipment and typically operate at a wavelength of 8-14um, with the IR spectrum equivalent to frequencies in the mid GHz to THz range. The temperature indicated may not be high (dependent also upon emissivity setting in the camera) however the point is that the surface PD in this case can be visually confirmed in addition to the dry banding observed in the accompanying digital photograph suggesting degradation to the heatshrink surface and modification of its insulation properties.
