TEV, One of the Most Misunderstood and Undervalued Partial Discharge Measurement Methods

By Greg Linton, HV Diagnostic Services Limited

CASE STUDY

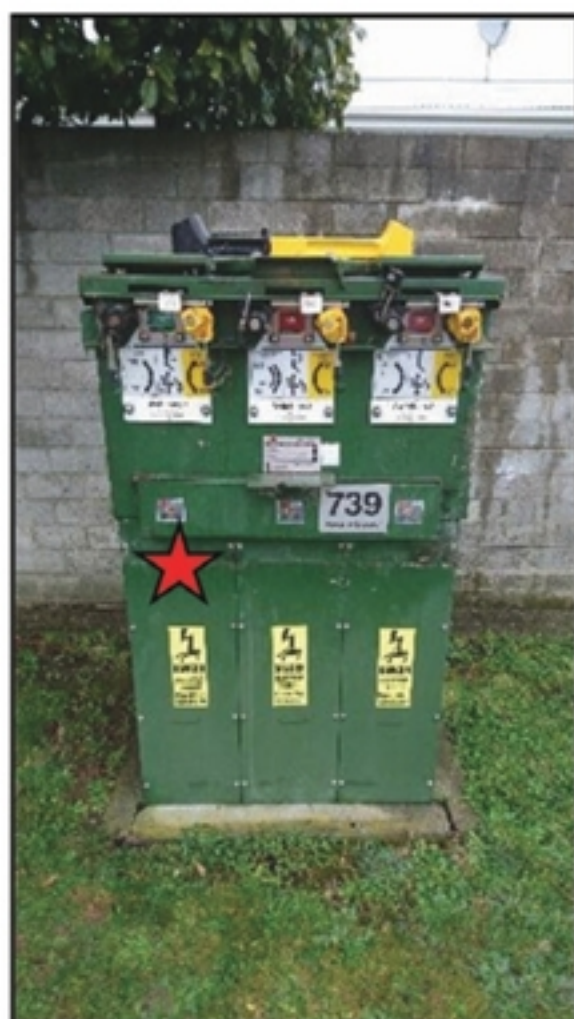
As suggested, Earth stakes were driven into the ground approximately 300mm at known joint locations which has the effect of physically moving our sensor closer to the subject under test and a reading obtained at the first joint out was 8dBmV higher on the day than the adjacent switch providing confidence that we were on the right track (diagram as received from Asset owner).

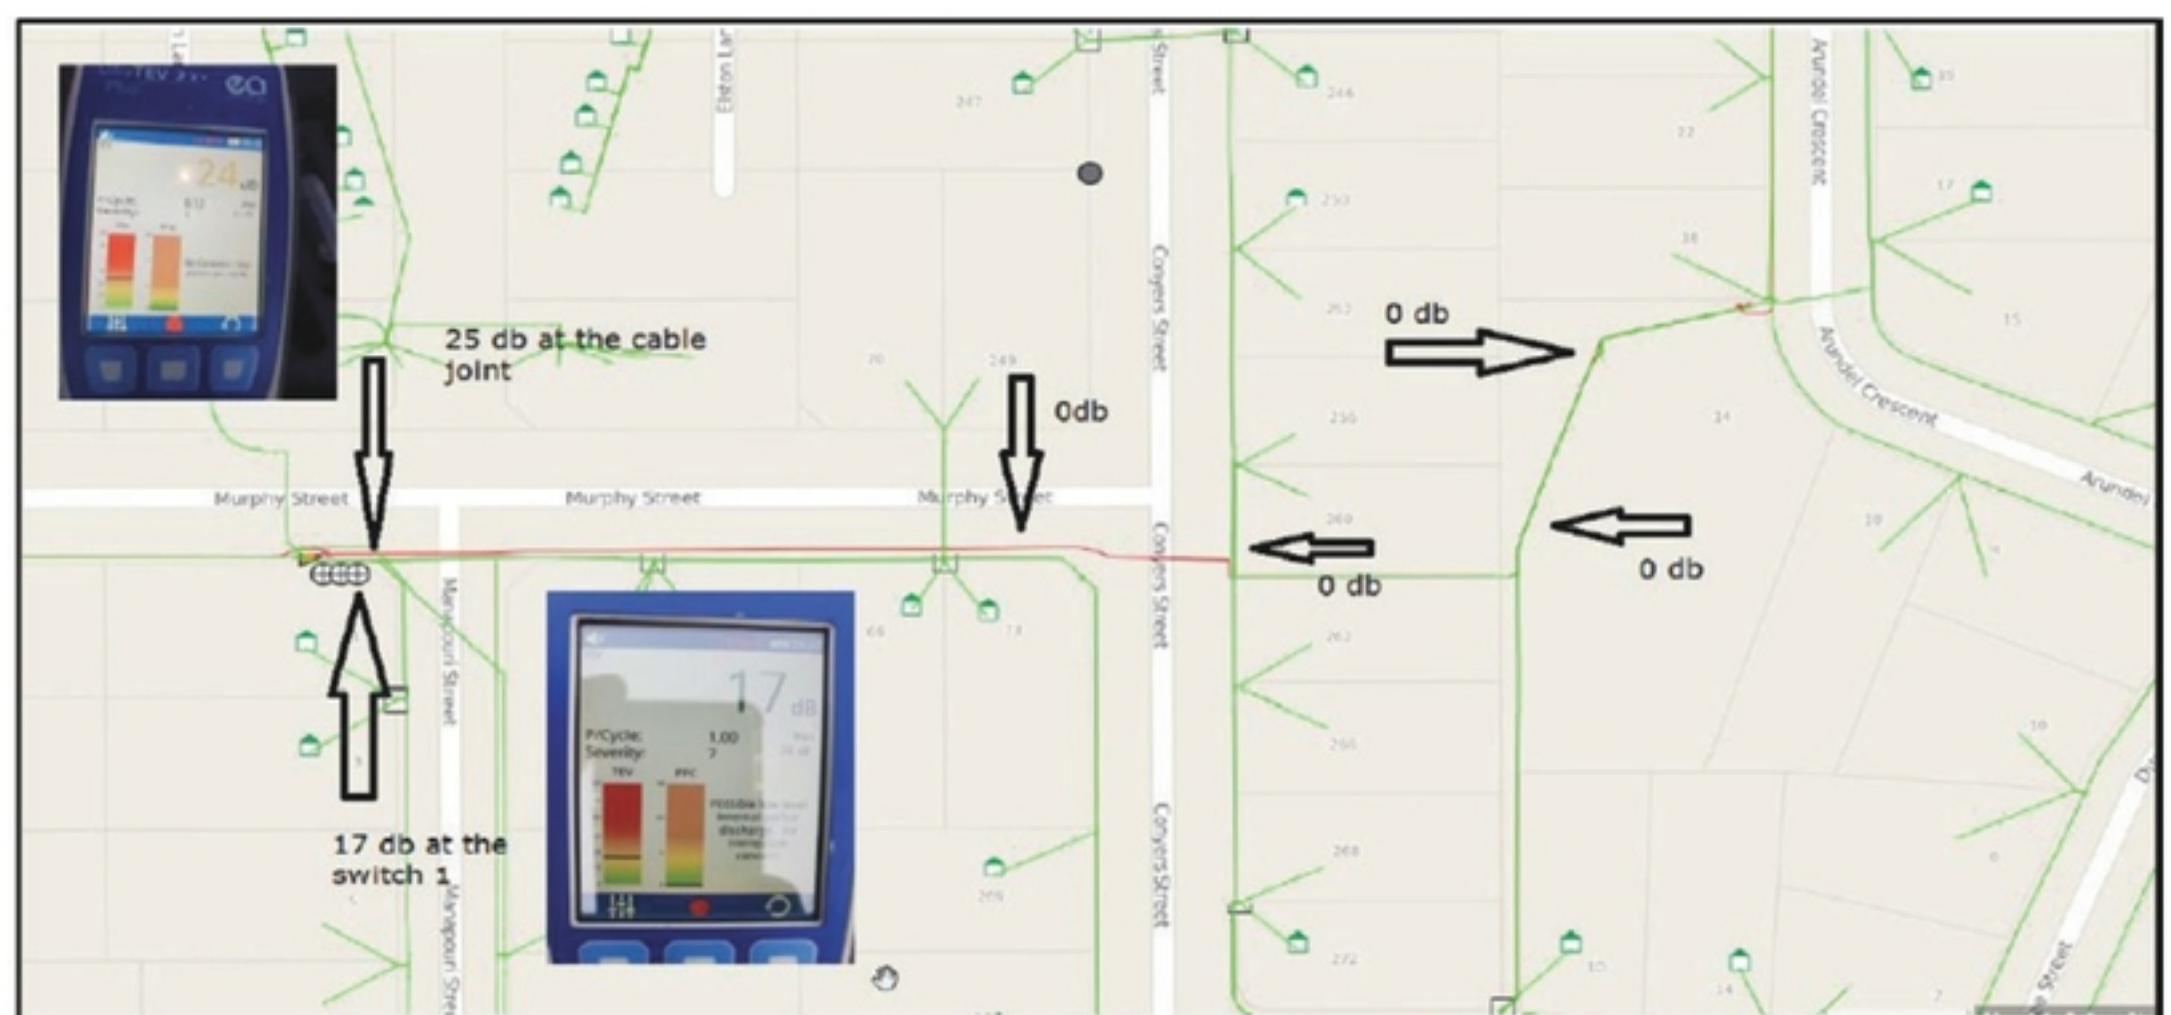
Above: 2020 TEV readings
Below: 2023 following maintenance

HVDS return visit in 2023 revealed a vast improvement in all switch readings, while the 2020 PRPD plot displays a text-book void

PANEL NAME	SWITCH POSITION (OPEN, CLOSED, EARTHED, ABSENT)	BUSBAR 1 UPPERFRONT	BUSBAR 2 LOWER/REAR	SWITCH TANK	CT CHAMBER	VOLTAGE TRANSFORMER	TERMINATION BOX
Sw No.1 to Sw2 @ 7433	O						33
Sw No.3 to Tx 739	C			36			34
Sw No.2 to Sw1 @ 725	C						36

PANEL NAME	SWITCH POSITION (OPEN, CLOSED, EARTHED, ABSENT)	BUSBAR 1 UPPERFRONT	BUSBAR 2 LOWER/REAR	SWITCH TANK	CT CHAMBER	VOLTAGE TRANSFORMER	TERMINATION BOX
Sw No.1 to Sw2 @ 7433	O						5
Sw No.3 to Tx 739	C			5			5
Sw No.2 to Sw1 @ 725	C						6

This joint, an original 3 core Paper Lead was exposed and further online PD measurement conducted on both this and the Termination Box. The joint was then replaced, three Core PILC to XLPE single Core x 3 Transition Joint and new singles terminated at the switch, the RMU was also serviced at the same time. Further 'in-house' testing indicated some PD still present at the joint which might suggest the existing aged PILC cable, but that the PD at the Cable Box had improved. Note there is no Ultrasonic activity present / nor able to be detected here while a lack of access to the cable screen 'energized' means using a HFCT sensor is not an option.

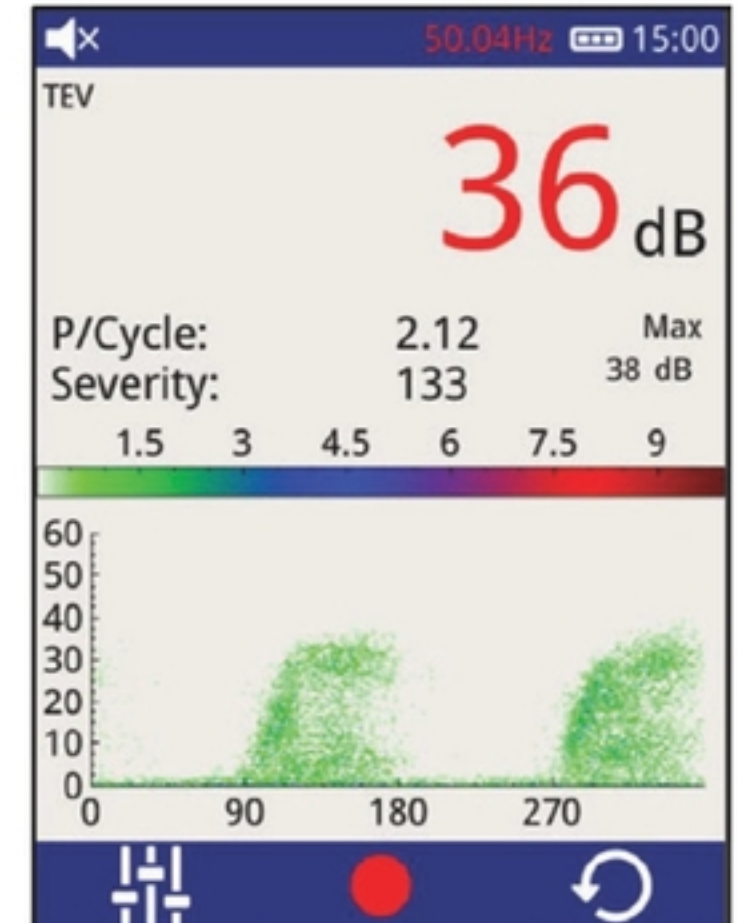
Right: 2020 PRPD
Sw No.1 to Sw2 @ 7433

discharge pattern by virtue of the two clusters spaced 180° and discharge active for what looks like most of each half cycle of the sine wave, and from a low inception Voltage. In this example an Amplitude of 36dBmV and Pulse rate of 2.12ppc gives rise to a Severity of 133, exceeding the threshold for investigation. The removed joint may not itself have been investigated but public safety has been improved at this berm site with the client later commenting 'But getting on top of these potential faults is good, We have had a lot of bad PR in that part of the network through 2021 and 2022'.
