# Evolution of Partial Discharge Detection Services - A Local Perspective

*By HV Diagnostic Services Limited, New Zealand*

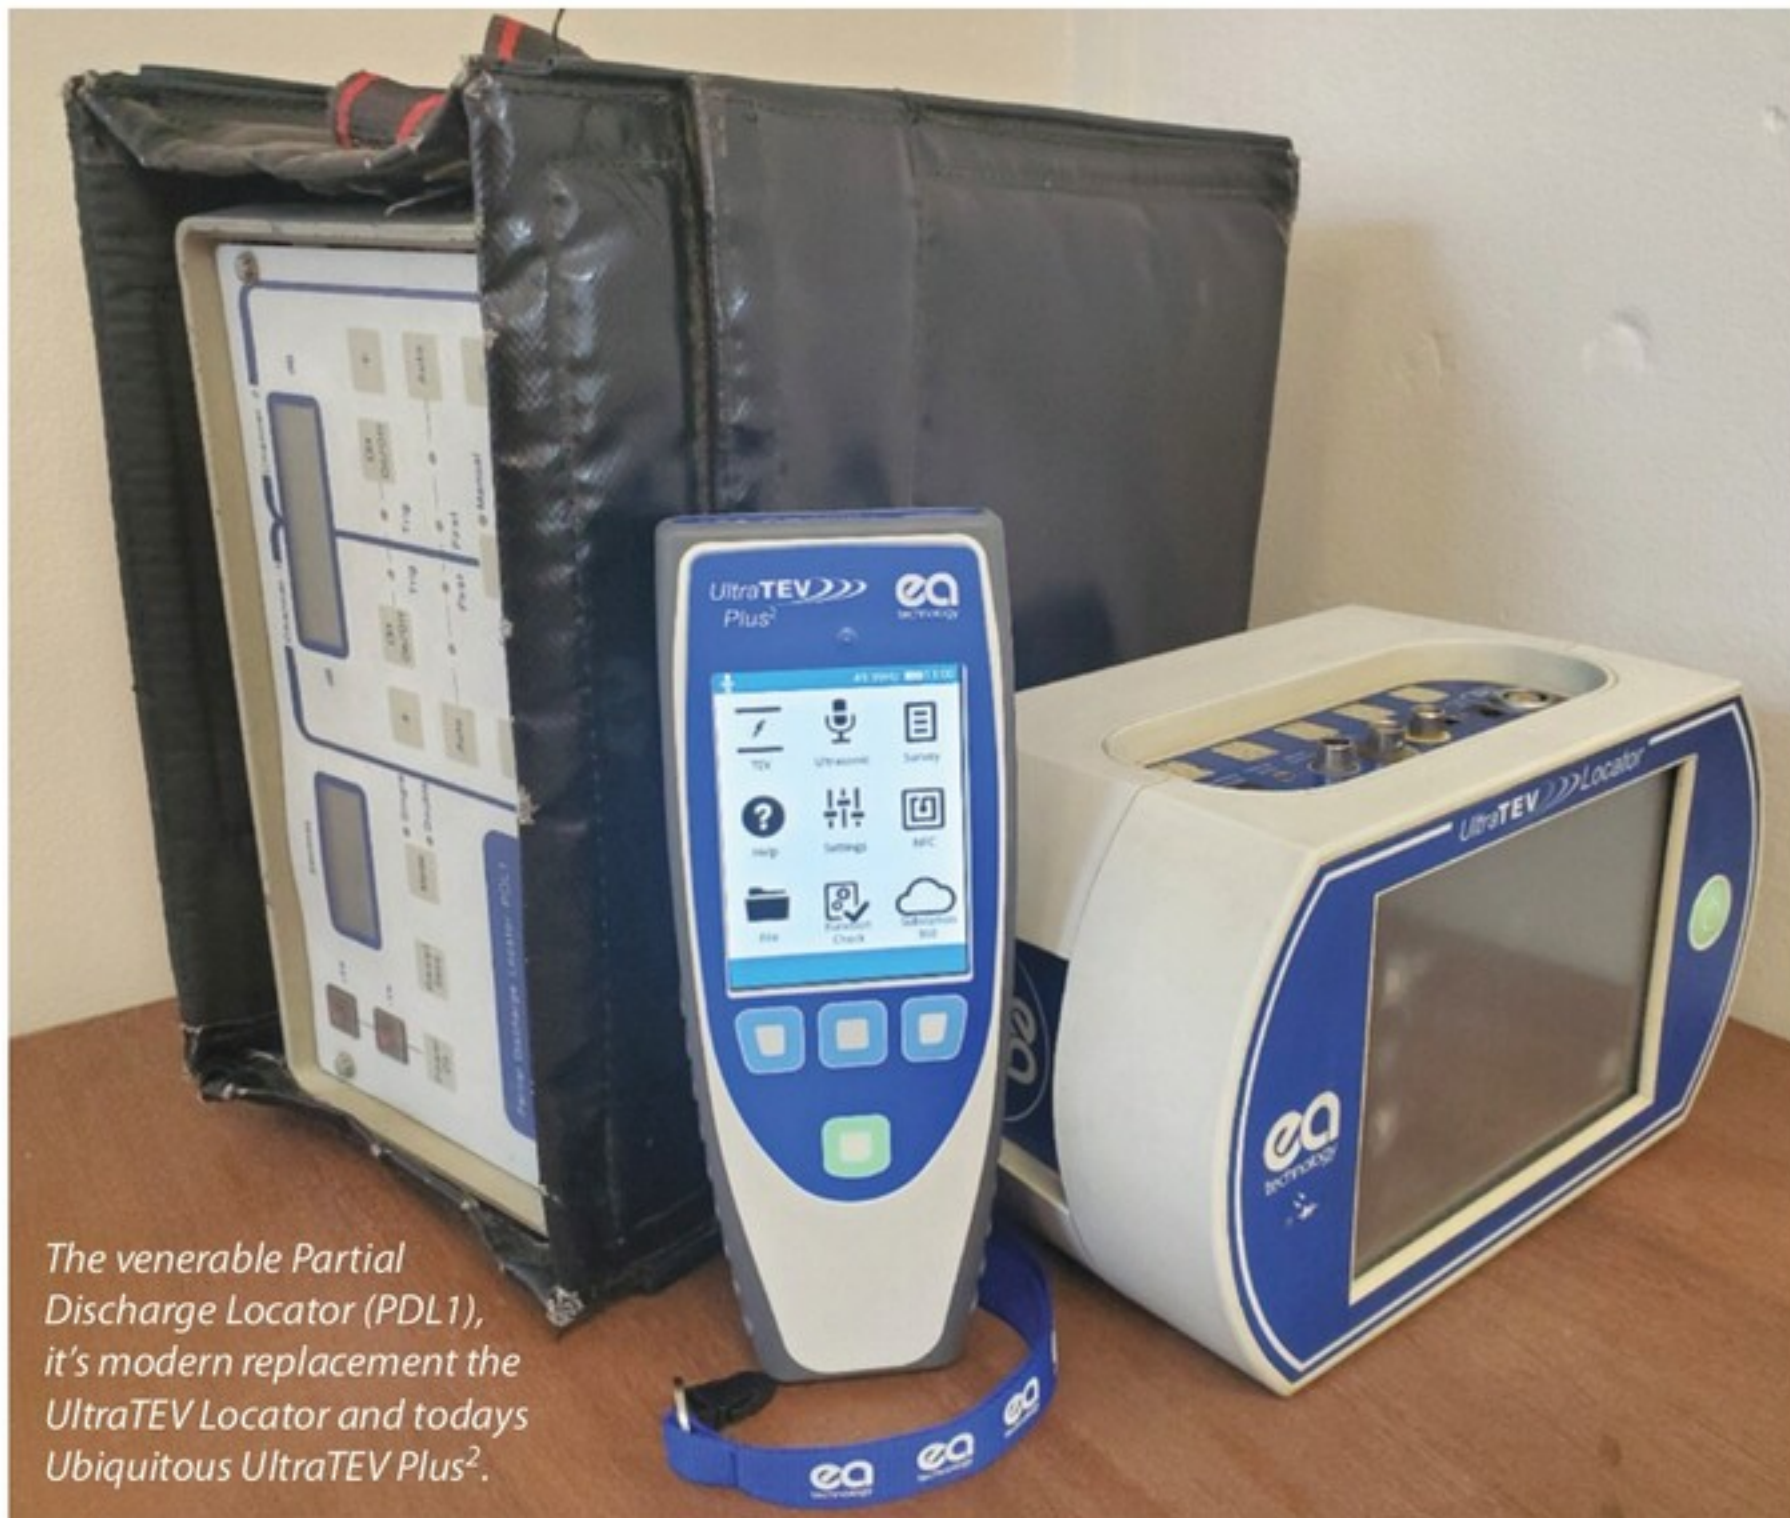
*The venerable Partial Discharge Locator (PDL1), its modern replacement the UltraTEV Locator and today's ubiquitous UltraTEV Plus<sup>2</sup>.*

Greg Linton was 'in on the ground floor' as Hamer Technology's Field Services Technician before purchasing the business and rebranding to HV Diagnostic Services Limited in July 2004. In those early days he got about the country with EA Technology's Partial Discharge Locator together with the separate, and equally unwieldy Detectaids T950 Ultrasonic Detector.

So, starting at the beginning with the Partial Discharge Locator and one of our most enduring finds. The PDL1 measured TEV, just Amplitude (no pulse counts or fancy PRPD here) but with the addition of the second probe and time of flight circuitry could determine the signal direction allowing the actual source to be pinpointed through comparison of signal arrival times. This switchboard was 1988 South Wales which included HG12 Vacuum breakers, with one of the seven feeders displaying

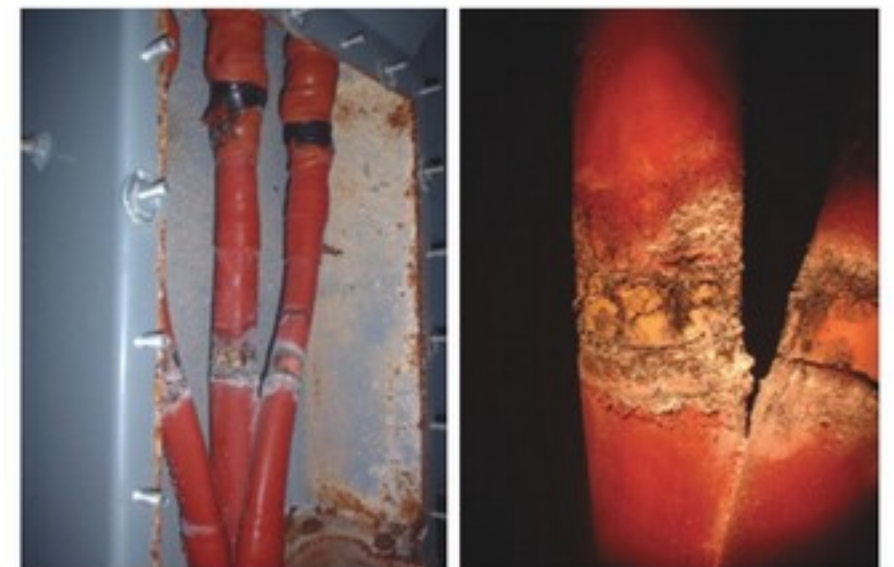
both elevated Switch Tank and Termination Box, 20dBmV above the Background and significantly higher than its peers. Double probing indicated the Termination Box was the source so despite its outwardly excellent appearance an outage was arranged. A box designed for compound but fitted with an Air-spaced Termination and gasketed 'shut' can sometimes develop into a problematic combination, in this case exacerbated by the coloured phase markings, their position and non-rated material ultimately responsible. This was detected during a routine survey allowing contractors to remedy and the Asset owner to avoid a certain failure.

discovered on their in-service equipment. The Network Operator was naturally delighted with the outcome and this particular epoxy-resin component is proudly part the HVDS collection of PD artefacts gathered over the years.

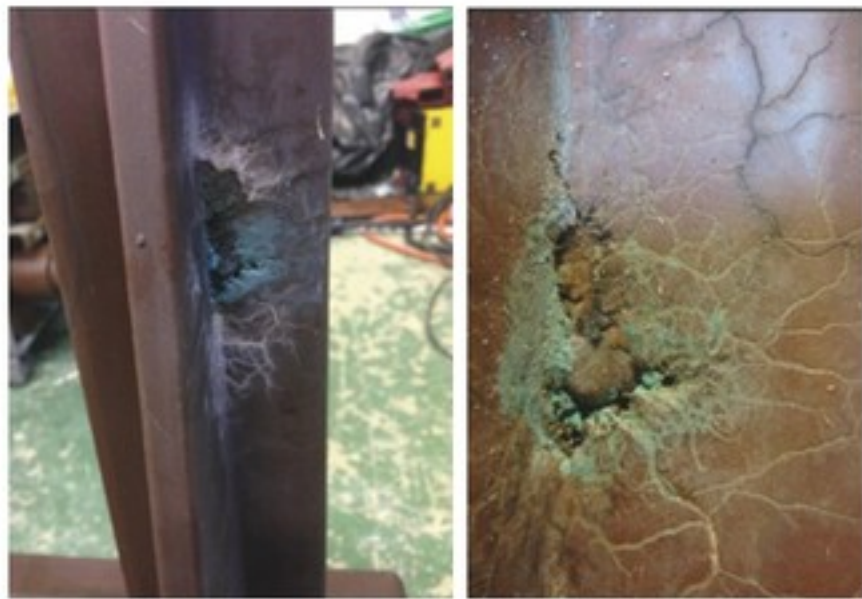
By 2014 we'd already been using the second-gen UltraTEV Locator for several years, an instrument considerably smaller and lighter than its predecessor but which also combined both TEV and Ultrasonic detection, plus function checking capability into a single package. Other improvements were the colour touch screen control, Pulse per cycle measurement and Severity calculation for TEV discharge, and this instrument also added a RFCT sensor for use on cables for the first time. A full suite of Ultrasonic accessories included a magnetic contact probe allowing assessment of sealed chambers where no air gap existed, and this could've been useful to us back in 2000. Here HV Diagnostic Services goes International assisting in the Pacific Islands to locate the source of an ozone smell within a critical Substation at the main Generation plant in the Nation's Capital (Oct 2014 back issue, <https://hvds.co.nz/wp-content/uploads/2020/11/hvds-pacific-2.pdf>). This defect displays impressive electrical treeing and erosion of the insulation surface as

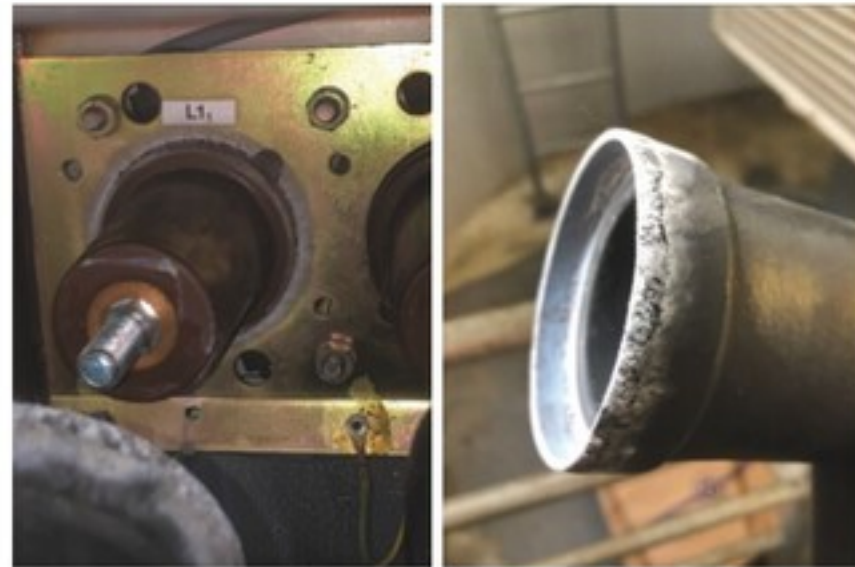
In this final case we encounter an anomaly generating both high TEV and Ultrasonic discharge activity. The UltraTEV Plus<sup>2</sup> instrument, currently the top of the tree for handheld PD survey tools offers a host of enhancements but, from the historical standpoint our favourites are the Phase resolved plots (with acquisition of suitable frequency reference), the ability to freeze and capture any screen to the microSD card, the wifi / hotspot connectivity and expansion of new features through ongoing firmware updates. Upon receiving the PD survey report, examination by the customer found the drain wire disconnected forcing capacitive current to find 'earth' off the end

of the screened elbow to the switch chassis requiring a new plug-in connector to be installed. In a cautionary tale, had this been acted on when first reported in late 2017 its possible only a minor cleanup rather than complete replacement would've been required; TEV levels had increased from 18 to 56dBmV and Ultrasonic activity 46 to 58dBuV in those ensuing years.
